LANDSLIDES AND RELATED FEATURES

OF THE COBHAM, PA. QUADRANGLE

by
John S. Pomeroy
1981

U.S. Geological Survey
OPEN FILE MAP 81-238 (F-6)

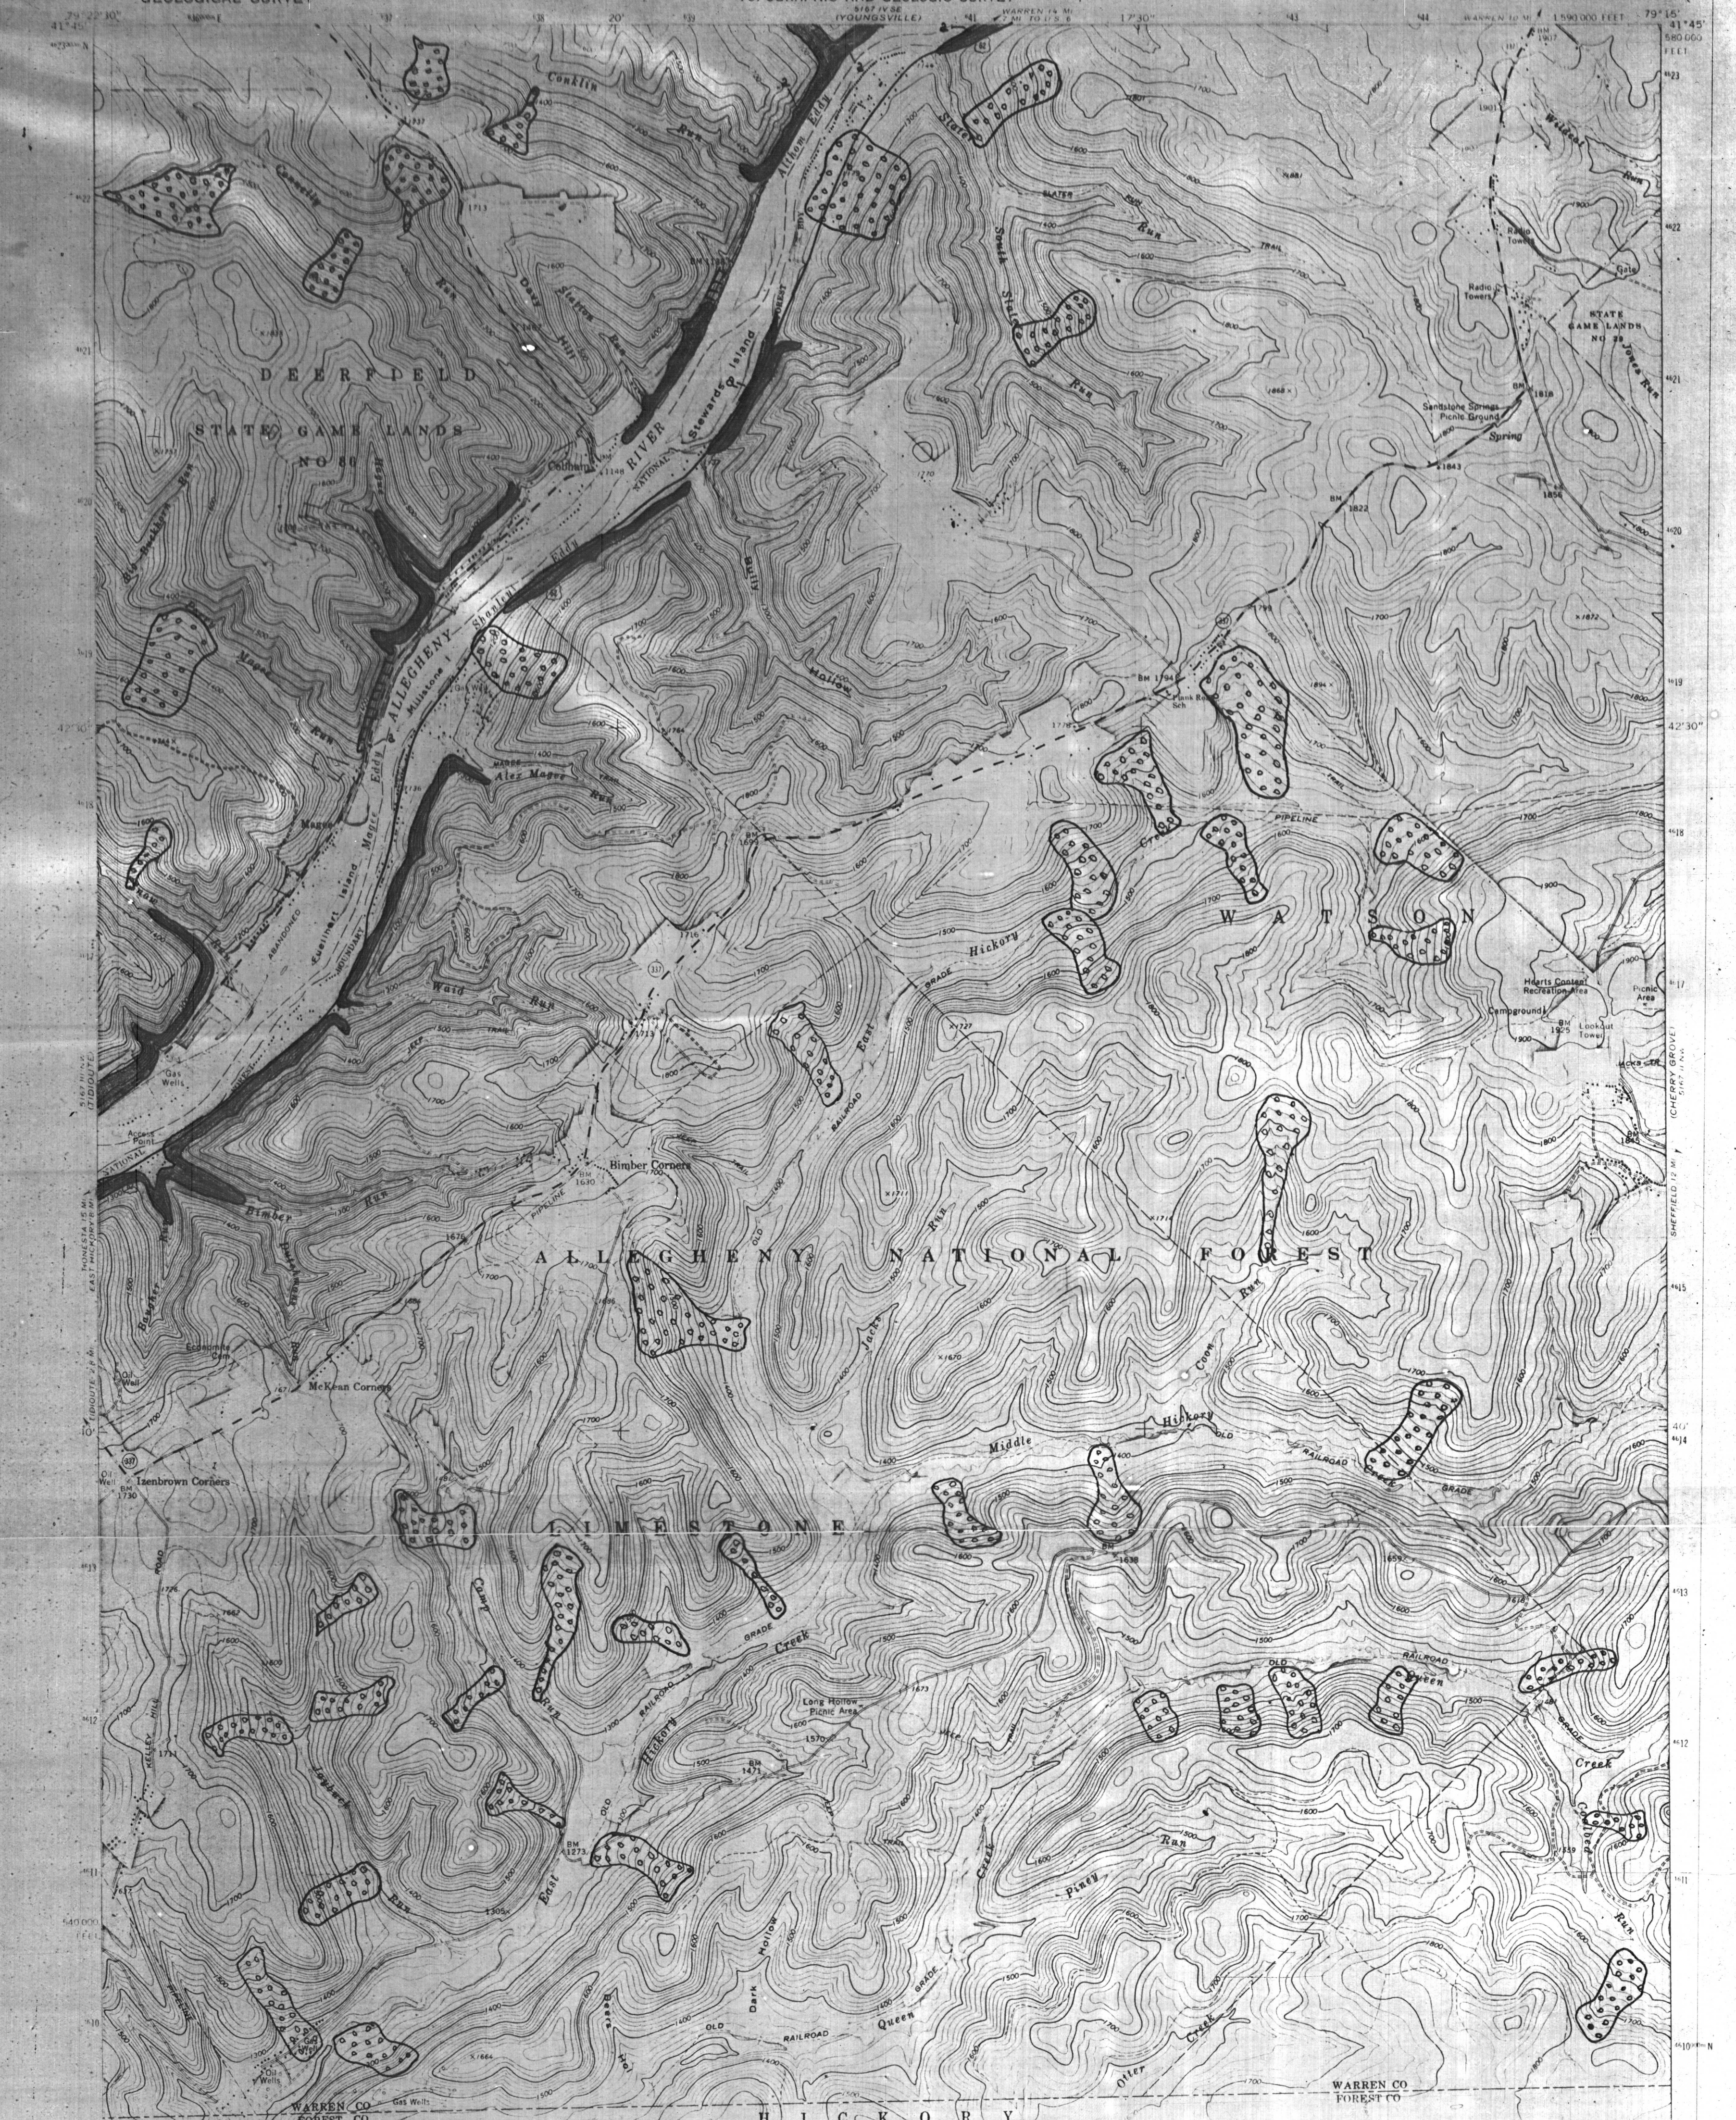
Landslides and related features interpreted
from aerial-photographs:

ACTIVE OR RECENTLY ACTIVE LANDSLIDE

Complex landslide composed of earthflow, debris
slide, earth and rock slump. Identified from
historical records, and from scars, debris and
other field evidence. Ground extremely unstable;
sliding accelerated by excavation, loading and
changes in drainage conditions. May include
areas with several active slides too small to
be shown separately. Questioned where doubtful.
May be shown with symbol (A) where difficult to discern.

OLD LANDSLIDE

Area of extensive hummocky ground caused by
earthflow and earth and rock slump. Lacks
clear evidence of active sliding. Relatively
stable in natural, undisturbed state,
generally not affected by small structures properly
sited in areas away from the edge of the toe;
can be reactivated by extensive, rapid exca-
vation, loading, and changes in ground water and
surface water conditions. Area of old landslide
probably includes recent ones not identified
from field evidence or otherwise documented.
Upslope boundary of landslide generally defined
by modified scarp, but down slope (toe) may be
gradational and not well defined. Questioned
where doubtful.

COLLUVIAL SLOPE

Valley wall along major streams with slope as
steep as 40° (85%); stony, clayey silt soil up
to 50 ft. (15 m) thick; commonly buttressed by
a terrace or bench at the toe of the slope; very
susceptible to sliding by cutting of toe area,
removal of terrace or bench, and overloading;
slide commonly activated without apparent cause.

AREAS SUSCEPTIBLE TO DEBRIS FLOWS AND DEBRIS

AVALLANCHES

Primarily shallow, narrow ravines and chutes with
accumulation of stony colluvium generally 10 ft.
(3 m) or less in thickness; susceptible to rapid
movement during intense rainfall. Most ravines
and chutes designated show evidence of former
debris flows and avalanches. Symbol & desig-
nates historical debris flow or debris avalanches.

AREAS SUSCEPTIBLE TO ROCKFALL

Steep, locally vertical, natural and man-made
slopes and cliffs, 15 ft. (4.5 m) or more high;
formed dominantly of sandstone, limestone, sandy
shale, mudstone and claystone. Interbedded mud-
stone, claystone and shale weather rapidly leaving
sandstone and limestone rock faces unsupported.

SOIL AND ROCK SUSCEPTIBLE TO LANDSLIDING

Soil and rock similar to that involved in land-
slides elsewhere in map area; primarily areas
underlain by claystone, mudstone and shale
associated with other rock types. Rock weathers
rapidly on exposure forming clayey soil highly
susceptible to sliding. Includes coves (U-shaped,
shallow valleys) containing thick layers of clayey
soil that are very susceptible to sliding where
excavation breaks continuity of slope and where
overloaded by artificial fill.

AREAS LEAST PRONE TO LANDSLIDES

Map areas in which no patterns or symbols are shown;
primarily valley floors, ridge tops and broad
benches; modification by excavation and fill may
lead to local landslides.
Includes slopes where landslides are sparse.

Quadrangle does not contain
landslides or related features.

NOTE
Information shown is intended as a
general guide to ground conditions as of
the date of field check. Additional
landslides and rockfalls should be anticipated
in all map units. The map unit depicts
the dominant condition in the area delineated
and variations in slope stability may occur
at any point in the unit. This map is suit-
able for general planning purposes and as a
supplement to more detailed studies for site
selection. The map cannot be used as a sub-
stitute for detailed geologic and engineering
investigations to establish design and
construction criteria of specific sites.
Some symbols may not appear on this map
because the description is applicable to a
series of maps.

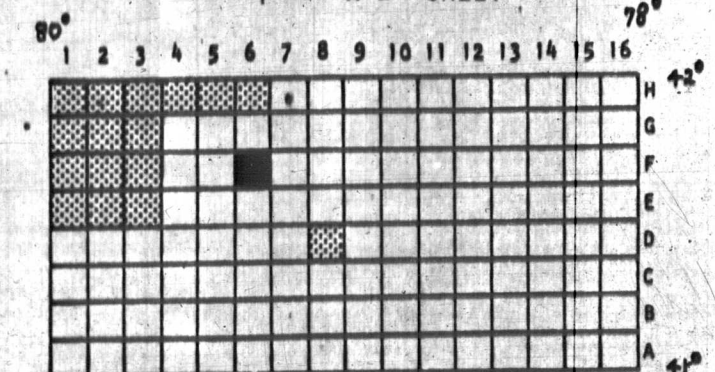
WARREN 1° X 2° SHEET

The first five digits of the open file number designate the
specific 1:250,000 scale map sheet of which this quadrangle
is a part. The last two digits designate the position of the
quadrangle in a subdivision of the 1:250,000 scale map based
on rows and tiers shown in the diagram to the right. The
location of this quadrangle is shown by the black square.
